Manhole Inspection Summary

Manhole # S35C__077MH

Location Address: **rear 323 pleasant st**

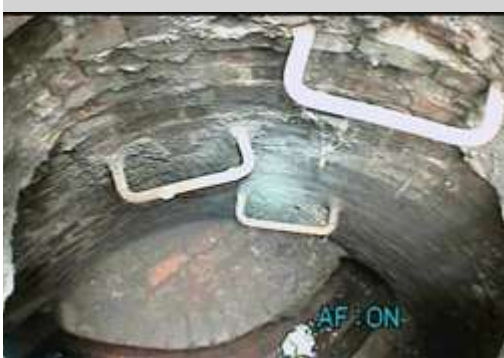
Defect 2

Steps Count: **3** Missing: **0** ☒ **Corroded**

steps

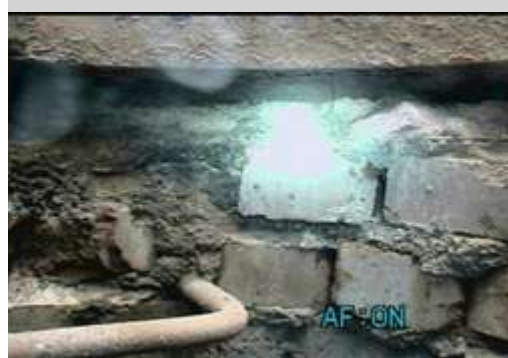
Defect 1

Condition: ☐ Sound ☐ Cracked ☐ Root Intrusion ☒ **Loose Brick** ☒ **Deteriorated**

chimney loose bricks,deteriorated,
frame adj

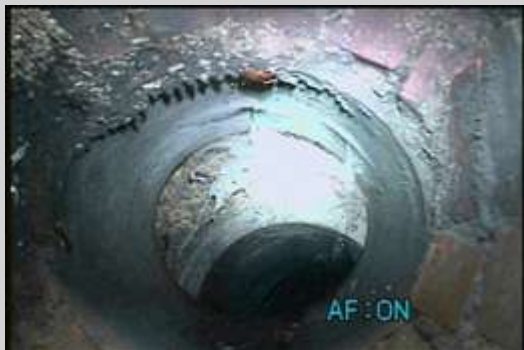
12 O'Clock Outflow

10 in. Circular Gravity Sewer
Pipe Out @ 12 O'Clock

Invert Depth: 6.63 (ft.) Flow Characteristics: **Slow**

Infiltration: **None** Pipe Seal Cond: **Unknown**

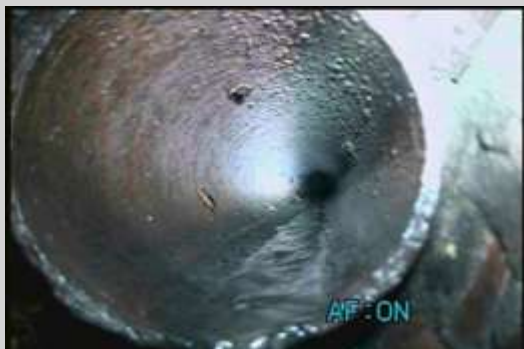
9 O'Clock Inflow

8 in. Circular Gravity Sewer
Pipe In @ 9 O'Clock

Invert Depth: 6.10 (ft.) Flow Characteristics: **Slow**

Infiltration: **None** Pipe Seal Cond: **Unknown**
